CRYSTAL LAKE DAM

JEFFERSON COUNTY, MISSOURI

MO 30462

PHASE 1 INSPECTION REPORT NATIONAL DAM SAFETY PROGRAM

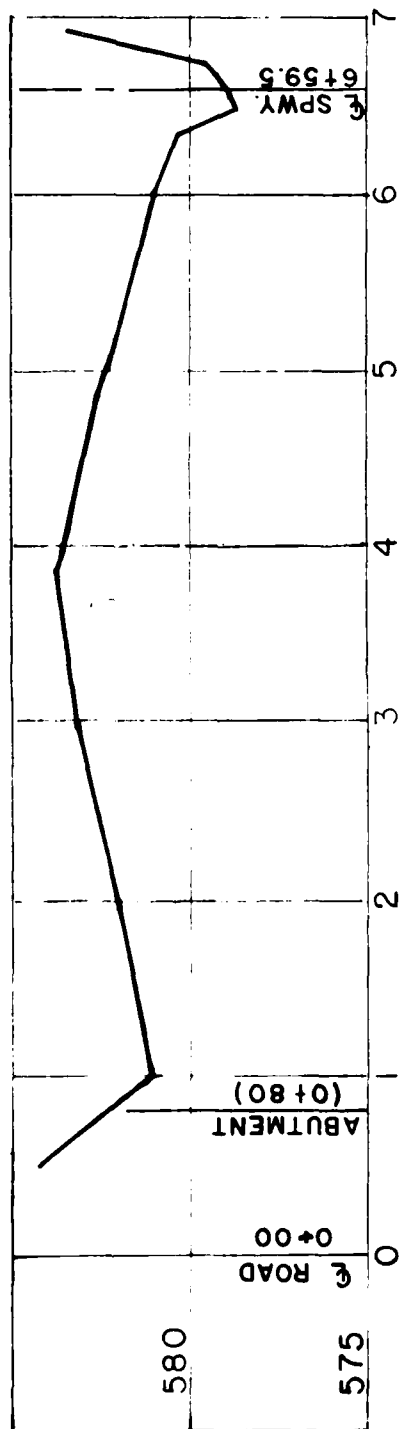
PROFILE DAM CREST
SCALES: 1" = 5' V., 1" = 100' H.

The elevation of the top of the dam near the right (looking downstream) abutment, as determined by survey, was found to be approximately 3 feet lower than the top of dam in the area near the center of the dam. A profile of the dam crest centerline is shown on Plate 3.
